Malaysian Technical Universities Conference on Engineering & Technology 2012, MUCET 2012
Part 3 - Civil and Chemical Engineering

Shear Behaviour of Pre-cracked Continuous Beam Repaired using Externally Bonded CFRP Strips

Noorwirdawati Ali ^{a*}, Abdul Aziz Abdul Samad ^a, Noridah Mohamad^a, J. Jayaprakash^b

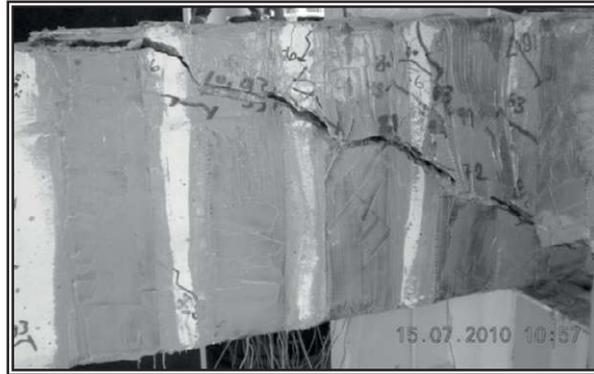
Fig. 6.: Shear failure of Beam 2-1 at load 373.70kN (shear force 122.39kN)

The beam was then strengthened at four sides of the beam with CFRP strips. It was later sustained with 10kN load for one week (second phase). After one week, the beam was loaded again up to failure. Failure of the beam occurred at a total applied load of 373.7kN due to the shear with rupture of CFRP strips along the shear crack. It shows an increase of 30.62% of the shear capacity compared with control beam (Beam 1-0) and slightly lower shear capacity than initially strengthened beam C2.5-UA-V with 2.09% different.

During the loading (third phase), the first crack appeared after repaired with CFRP was recorded at the area between the point load. The crack was an extended crack from pre-crack phase. For most of the earlier existed cracks from the first phase of loading, it extended further towards the compression zone within the mid-span area. As the load increases, new cracks began to appear at the tension zone which widened and propagated to the compression zone of the beam. At negative moment region, the existing cracks extended and move downwards at higher load than the cracks at mid-span area. New cracks were also observed at the negative moment region which appeared at concrete surface between CFRP strips at upper beam area and moves downwards to the compression zone. However, at failure, the cracks did not pass one third of height of the beam where some of it was recorded to stop when it reached CFRP.

As for diagonal cracks, the existing cracks extended and widened along the shear span. As the load increases, new

diagonal cracks were observed to be appeared at both inner shear span and outer shear span. At failure, a diagonal crack was clearly seen along the critical shear span with rupture of all five CFRP strips as shown in Figure 6. It was also observed that more diagonal and vertical cracks appeared at the tension zone of the negative moment region. For this beam, a broke of stirrups was also observed as shown in Figure 7. The stirrup that broke was the second stirrups closer to the middle support.

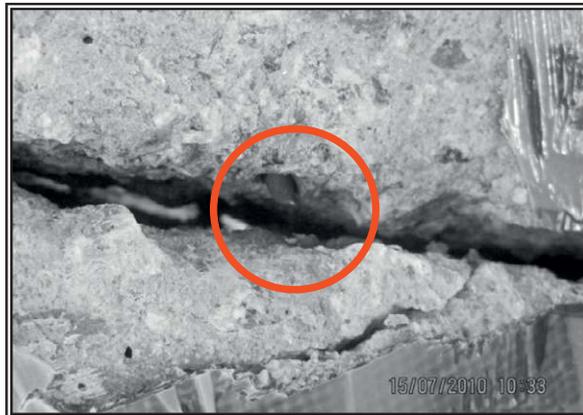
Fig. 7. Stirrup failure of Beam 2-1 at load 373.70kN (shear force 122.39kN)

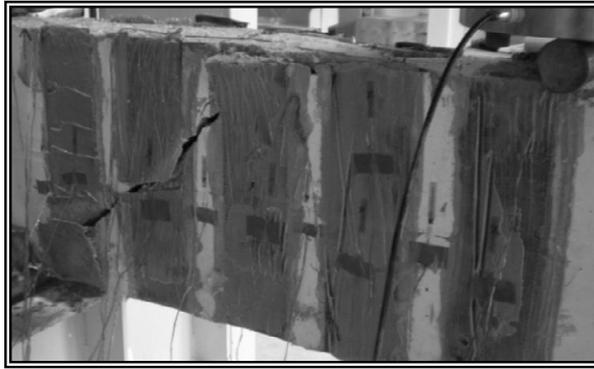
Fig. 8. Shear failure of Beam 2-2 at load 338.08kN (shear force 110.72kN)

After repaired with CFRP strips, the beam was loaded to failure where the ultimate load achieved was 338.08kN. The mode of failure for this beam was shear with CFRP strips rupture and debonding of the CFRP strips from the concrete surface. Figure 8 and 9 shows the cracks of the beam at failure. Figure 9 shows the top view of the beam where the cracks were extended along the concrete covers.

The increment of shear capacity for this beam was 18.16% compared with control beam (Beam 1-0). It was the lowest increment compared with the other beams. This is due to its condition as a pre-cracked beam and wrapped at three sides of the beam with CFRP strips oriented at $0^\circ/90^\circ$ orientation. From the observation on the crack pattern, it was observed that for four-sides wrapped beams, the diagonal crack occurred throughout the inner shear span from the bottom of the middle support to the location of the applied load. However, for three-sides wrapped beams, the diagonal crack was shorter than the four sides wrapped beams.

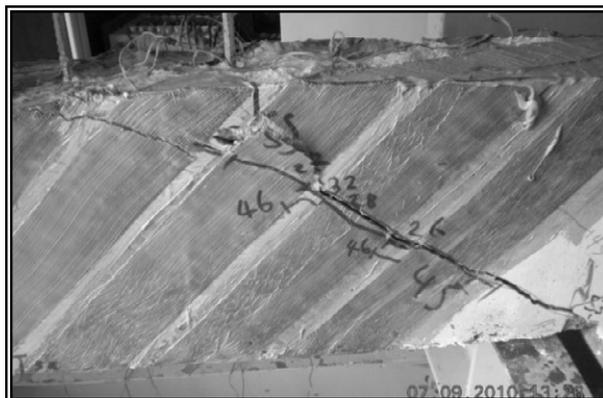
Fig. 11: Shear failure of Beam 2-4 at load 380.74kN (shear force 124.69kN)

The ultimate load achieved for this beam was 380.74kN with the mode of failure by shear with CFRP rupture and debonding of CFRP strips from the concrete surface as shown in Figure 11. The increment of the shear capacity was about 33.07% from the shear capacity of the control beam (Beam 1-0). It decreased at about 10.67% compared with Beam 2-3 (same orientation but wrapped at four-sides of the beam) but increased at about 14.91% compared with Beam 2-2 ($0^{\circ}/90^{\circ}$ degree orientation wrapped at three sides of the beam).
