Research Article

Corrosion Measurements in Reinforced Fly Ash Concrete Containing Steel Fibres Using Strain Gauge Technique

V. M. Sounthararajan and A. Sivakumar

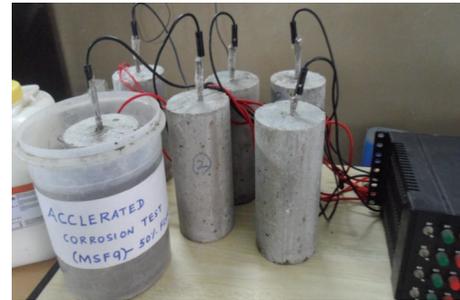
FIGURE 3: Snapshot for concrete specimens immersed in 3.5% sodium chloride solution.

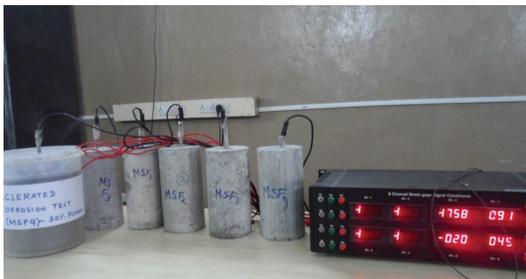
FIGURE 5: Accelerated corrosion test setup of concrete specimens connected to strain gauge conditioner.

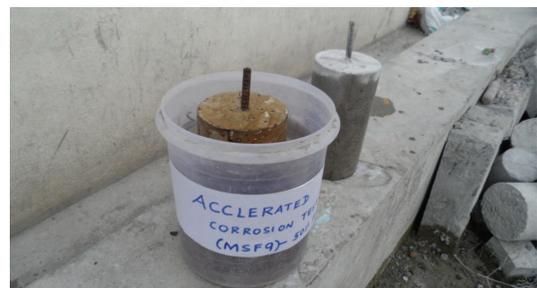
FIGURE 6: Snapshot of corroded rebar with rust stains on concrete surface.

developed in the concrete specimen, measured from the strain gauge sensor, was used to identify the corrosion process and snapshot of corroded rebar with rust stains on concrete surface as shown in Figure 6.

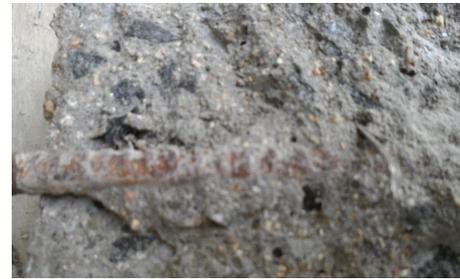
FIGURE 10: Snapshot of plain concrete specimens with corroded rebar.
