In situ study on fracture behaviour of white etching layers formed on rails

2019

Acta Materialia

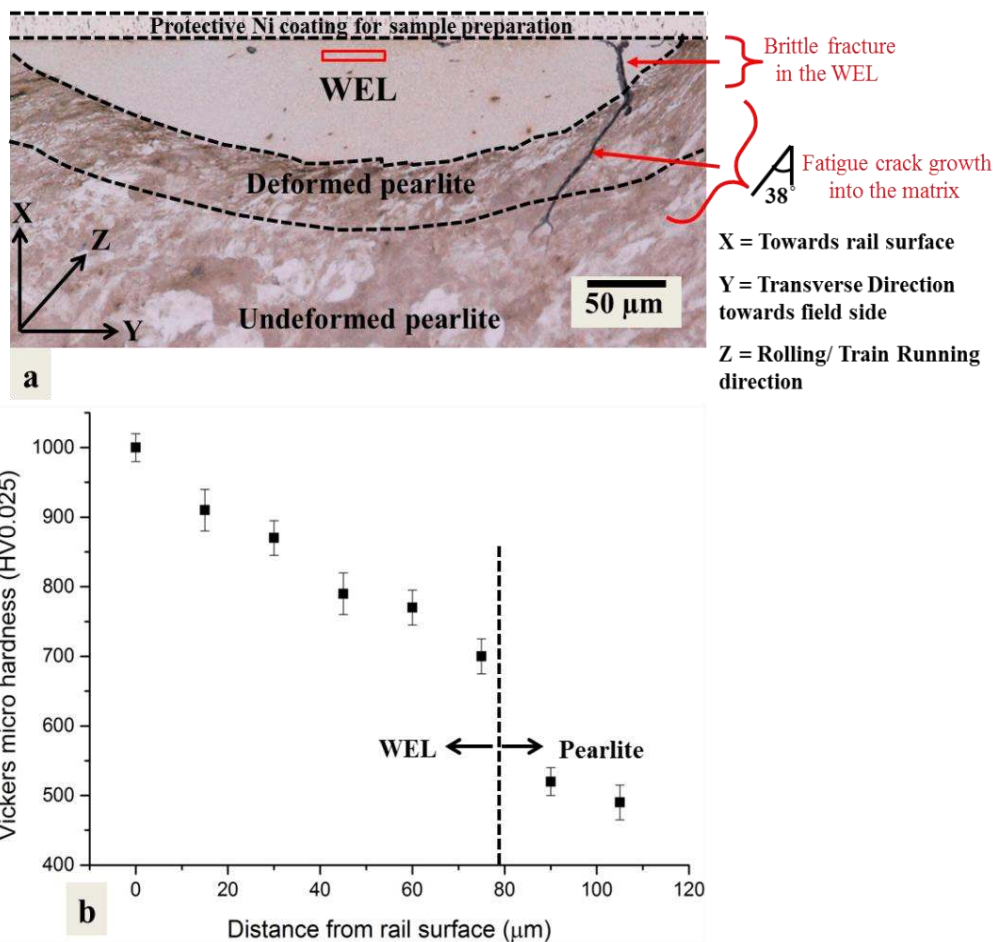
Fig. 1. Optical micrograph of brittle cleavage in the white etching layer that formed at the rail surface and crack propagation into the base pearlitic matrix. The red rectangle shows the position of the micro-cantilevers, (b) Micro hardness from the rail surface to the depth.

Fig. 1(a) is an optical micrograph showing the brittle failure of the WEL followed by fatigue crack propagation into the deformed and undeformed pearlitic matrix. The crack in the matrix grows at an angle of around 38° to the loading direction (opposite to the X direction in Fig. 1(a)), which is close to the direction of maximum resolved shear stresses (*i.e.* 45°). However, the crack in the WEL seems unaffected by the maximum resolved shear stresses and grows by brittle cleavage (Fig. 1(a)). The WELs are harder than the base pearlitic matrix: Fig. 1(b) shows the variation of micro hardness from the rail raceway into the rail matrix material. The hardness in the WEL is maximum (1000 ± 25 HV) close to the rail raceway and decreases towards the base matrix (Fig. 1(b)). The hardness is 710 ± 20 HV close to WEL/deformed pearlite interface. The maximum thickness of the WEL in this case is around 80 μm .

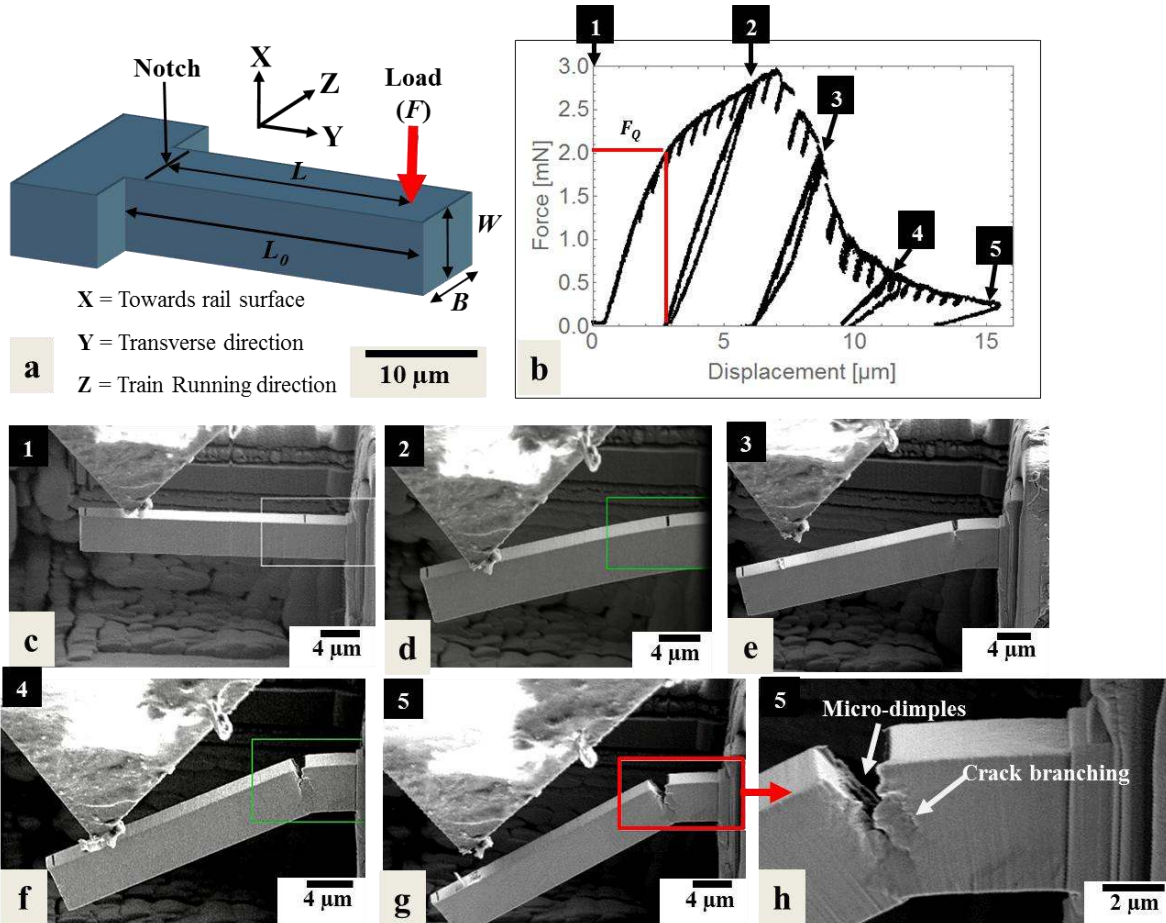
Fig. 2. *In situ micro-cantilever deflection experiments.* (a) schematic of the microcantilever used for *in situ* bending, (b) Load-displacement (F - d) curve of the WEL marked with four intermediate deformation steps (6 μm , 8 μm , 12 μm , and 15 μm), (c) WEL microcantilever before start of bending test, (d-g) SEM images of cantilever during four intermediate deformation steps *i.e.* (d) 6 μm , (e) 8 μm , (f) 12 μm and (g) 15 μm , (h) magnified SEM image of the WEL cantilever after 15 μm displacement, showing crack branching and micro-dimples on the fracture surface.

The schematic of the microcantilevers and the coordinate system of the cantilever with respect to the rail are shown in Fig. 2(a). The intended crack plane in the microcantilevers is parallel to the XZ plane (Fig. 2(a)) where X is the rail surface normal and Z is the train running direction. A representative force (F) displacement (d) curve from the WEL microcantilever is shown in Fig. 2(b), in which the repeated loading/unloading sequences are used to measure the cantilever compliance and deduce the crack propagation evolution. The crack propagation at various steps (at 6 μm , 8 μm , 12 μm , and 15 μm) during the *in situ* microcantilever deformation are shown in Fig. 2(c-h). The force-displacement curve and crack tip behaviour highlight the elastic-plastic response of the WEL. The observed plasticity is attributed to the large plastic zone size and the complex microstructure of the WELs (discussed later in Sec. 3.6). The crack branching and micro-dimples are also observed (Fig. 2(h)), which reduce the effective crack intensity ahead of the primary crack tip and decrease the local driving force for crack propagation [41,42]. The complete fracture process of the WELs can be seen in the

experimental videos attached in supplementary information. When applying LEFM (according to Eq. 1 and 2) to the force-displacement curve shown in Fig. 2(b), the linear elastic fracture toughness (K_{IQ}) of the WEL is determined as $4.2 \pm 0.6 \text{ MPa}\sqrt{\text{m}}$ (error margin is estimated from statistical error propagation).

Significant plasticity is observed in the cantilever, as shown in Fig. 2(b). Thus, an elastic-plastic approach by Wurster *et al.* [33], is used to quantify the fracture toughness of the WEL. The unloading stiffness of cantilever is determined for each unloading segment and plotted against the displacement, as shown in Fig. 3(a). The cantilever stiffness continuously decreases with indenter displacement (Fig. 3(a)). The cantilever stiffness at each unloading step determines the instantaneous crack length (a_i), as evaluated by equation 3

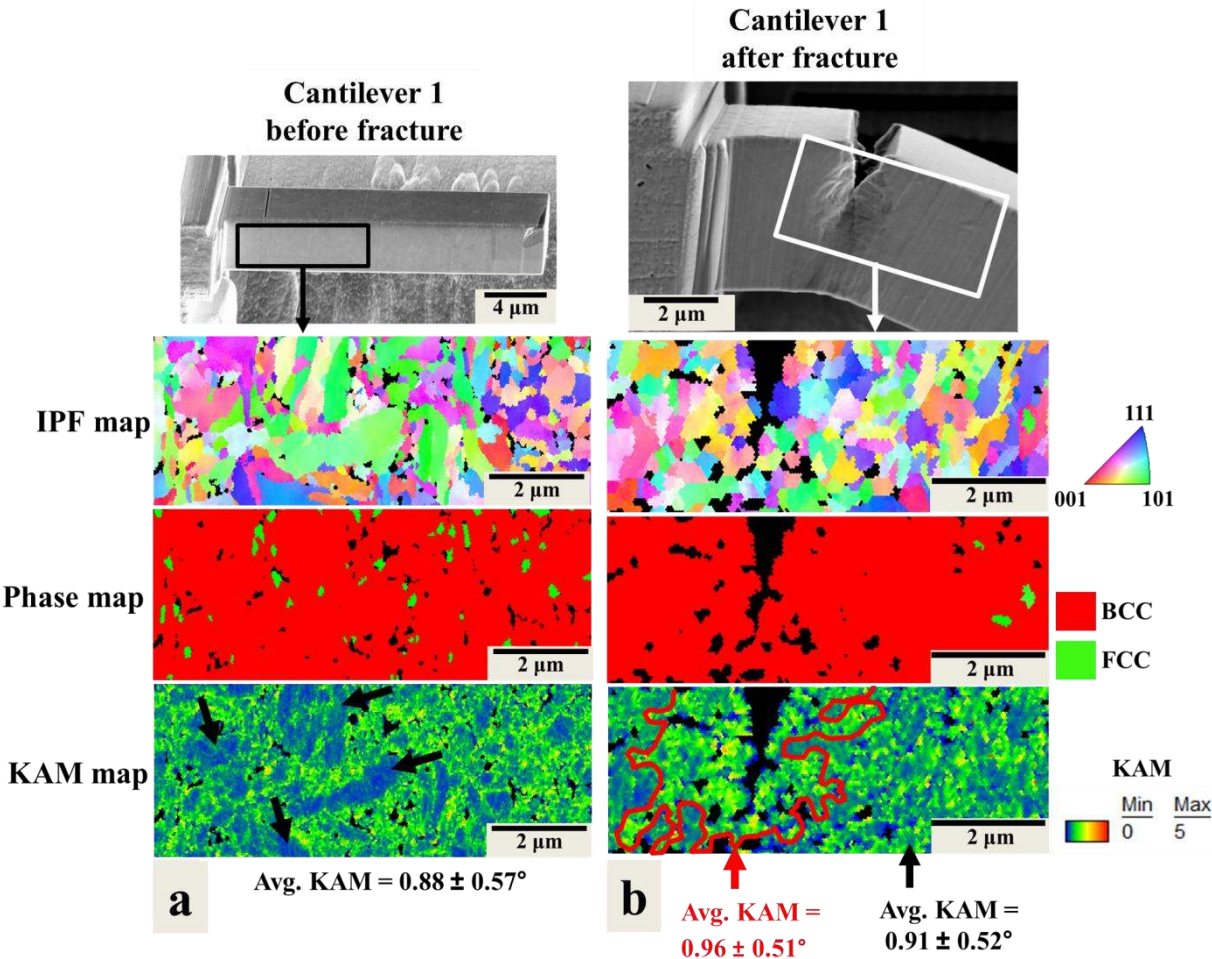
Fig. 6. EBSD results showing IPF, phase and KAM maps from the cantilever 1: (a) before and (b) after fracture. (Black colour arrows in the KAM map before the test show the martensitic grains with low KAM (0.39-0.50°)) (The high KAM area (enclosed in the red lines) on the KAM map in Fig. 6(b) represents the plastic zone associated with the crack).

Additional EBSD investigations were performed on cantilever 1 before and after fracture (Fig. 6). Alike cantilever 4, the observations show mixed intergranular and intra-granular fracture and strain-induced austenite to martensite transformation during the crack growth in cantilever 1 (as displayed in the IPF and phase map in Fig. 6(b)). We observe that the average KAM in cantilever 1 is 0.88° , with a standard deviation of $\pm 0.57^\circ$, before fracture (Fig. 6(a)), which corresponds to a GND density of $4.66 \times 10^{15} \text{ m}^{-2}$. The KAM map in Fig. 6(a) displays low KAM areas ($0.39\text{-}0.50^\circ$) (indicated by black arrows), which are not visible after the fracture experiments (Fig. 6(b)) as previously observed in cantilever 4 (Fig. 5).

Unlike cantilever 4, the KAM map from cantilever 1 (Fig. 6(b)) shows an area (enclosed in red lines) with a high average KAM of $0.96 \pm 0.51^\circ$ in the crack vicinity. This misorientation corresponds to an increased average GND density of $5.10 \times 10^{15} \text{ m}^{-2}$ (Eq. 7). This high GND density area can be attributed to the plastic zone near the crack. The observed plastic zone shape is complex due to the complex WEL microstructure containing grains with different sizes and orientations. The average KAM outside the plastic zone is 0.91° , with a standard deviation of $\pm 0.52^\circ$, which corresponds to a GND density of $4.82 \times 10^{15} \text{ m}^{-2}$.
