# Modeling and Assessment of Lightning Hazards to Humans in Heritage Monuments in India and Sri Lanka

**ABSTRACT** Lightning is one of the inevitable disastrous phenomena which in addition to damaging tall edifices, might also consequently endanger humans due to lightning-human interactions. This research focuses on analyzing lightning hazards to humans in the vicinity of heritage monuments in India and Sri Lanka. Five monuments which include three giant stupas namely Ruwanweliseya, Jethawanaramaya and Abayagiriyaya from Sri Lanka and two large temples namely Brihadishvara Temple and Gangaikonda Cholapuram from India have been chosen for investigation. Lightning-human interaction mechanisms namely direct strike, side flash, aborted upward leader, step and touch voltages have been investigated for the most onerous scenario on humans in the vicinity of the monuments. Firstly, the electro-geometric model as stipulated in standards has been implemented to ascertain the effectiveness of lightning protection to the structures. Subsequently, the study has been extended to the computation of step and touch voltages utilizing lightning current and electrostatic models based on Finite Eleme

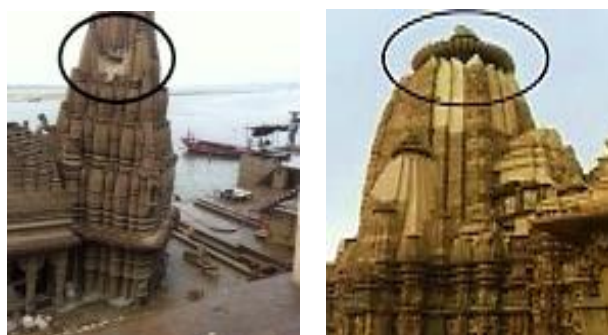
**FIGURE 3.** Brihadishvara Temple – Lightning strike damaged a sculpture in the top portion of the entrance tower (Keralanthagan gopuram) in 2018

| Heritage monument | Location and year | Nature of Lightning Damage |
|---|--|--|
| <b>Brihadishvara Temple- Keralanthagan Gopuram</b> | Thanjavur, India, 2018 | <ol style="list-style-type: none"> <li>1. A portion on the top right side of the gopuram was shattered and some pieces were felled.</li> <li>2. A portion of the structure known as 'Keerthimugam' (ornate sculpture) has been shattered and was damaged</li> </ol> |

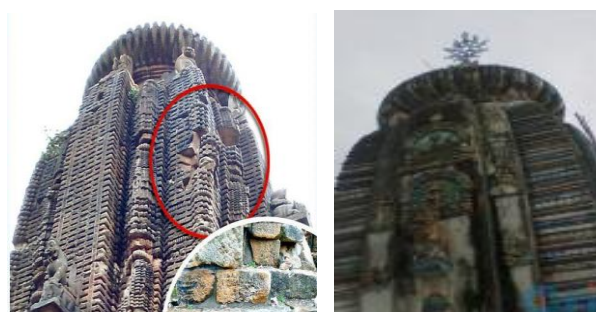
**FIGURE 4.** Lightning Damages (a) Rathneswar Mahadeshwar Temple and (b) Jagadambika Temple in 2016 and 2015 respectively

| Heritage monument | Location and year | Nature of Lightning Damage |
|---|--|--|
| <b>Ratneshwar Mahadev Temple (Leaning Temple of Kashi)</b> | Varansi, India, 2016 | <ol style="list-style-type: none"> <li>1. Damaged due to heavy lightning led to shattering of the spire which weighed nearly 50 kg, atop the temple tower</li> <li>2. However, there were no reports of injuries to human during the incident.</li> </ol> |

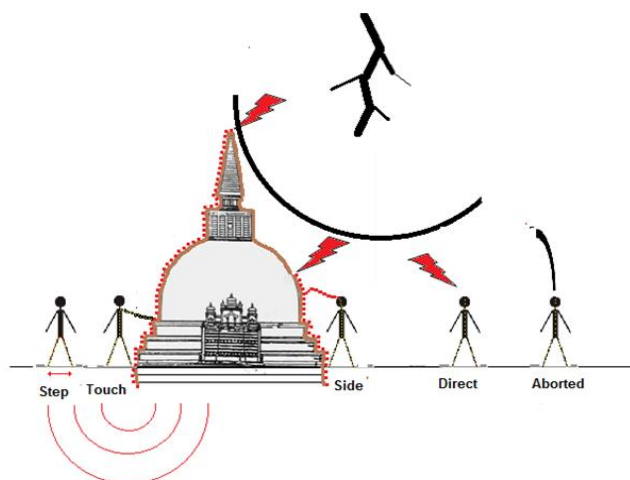
FIGURE 13. Lightning- human interaction mechanisms: Direct strike, side flash, touch potential, step voltage and aborted upward leader

Hence, considering the aforesaid lightning mechanisms, the ultimate effect and cumulative impact of exposure of human to lightning might result into very severe injuries and sometimes leading to fatal consequences due to cardiac arrest [33]. Fig.13 shows the five lightning human interfering mechanisms namely 1. direct strike to the human from the CG flash; 2. side flash due to a direct strike to the monument; 3. touch voltage due to the current flow through the down conductor; 4. step voltage due to CG lightning flash to a nearby area and 5. unsuccessful upward abort leader due to CG flash connecting to a nearby point.

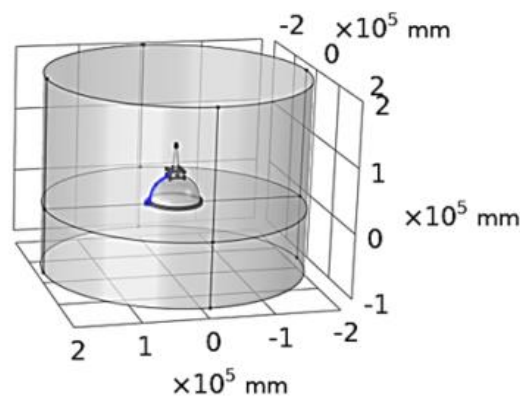
FIGURE 15. Typical COMSOL layout for monument for analysis of lightning-human interaction mechanisms

Fig. 15 and Fig. 16 depict the generic formulation of the 3-D representation of a stupa taken up for FEM based studies.

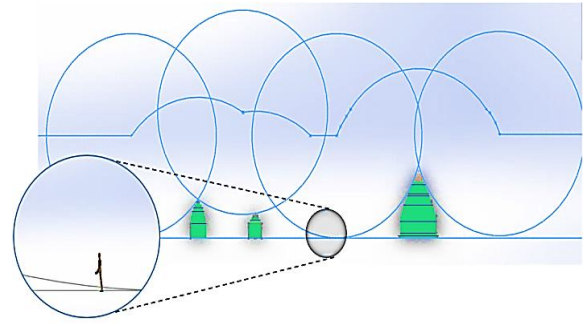
**FIGURE 26.** Loci of LPZ and vulnerable points of human in Big Temple

Fig. 22, Fig. 23, Fig. 24, Fig. 25 and Fig. 26 depict the loci of the leader tip and shielded area for a typical lightning current of 30 kA for the various stupas and temple monuments taken up for case studies of lightning protection zoning (LPZ). The onerous condition i.e. when the human is standing at the furthest point on floor has been analyzed to ascertain the risk of direct lightning strikes. It is evident from the detailed studies and analysis of the simulation that Ruwanweliseya stupa and Gangaikonda Cholapuram temple have no risk for devotees from direct strikes for 30 kA lightning current. However, it also evident that the boundary lines of the rolling sphere computed and generated for 30 kA passes through the body for the most critical location in Jethwanaramaya, Abayagiriya stupas as well as Brihadesvara temple. From the context of the area affected with respect to the overall floor of the monument, the risk of direct strikes to such places is very minimal. Thus it is obvious that the devotees are nearly shielded by the monument structure against direct lightning, though in the case of the big temple as depicted in Fig. 25, the devotees inside the nandhi mandapam may be vulnerable to strikes.

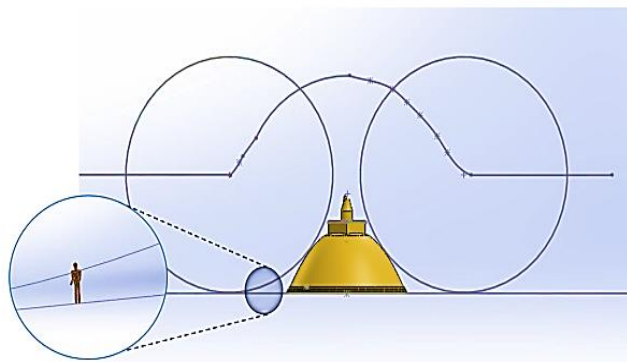
**FIGURE 23.** Loci of LPZ and vulnerable points of human in Jethawanaramaya

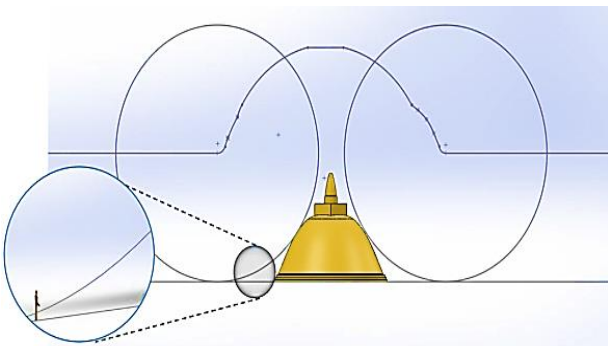
**FIGURE 24.** Loci of LPZ and vulnerable points of human in Abayagiriya

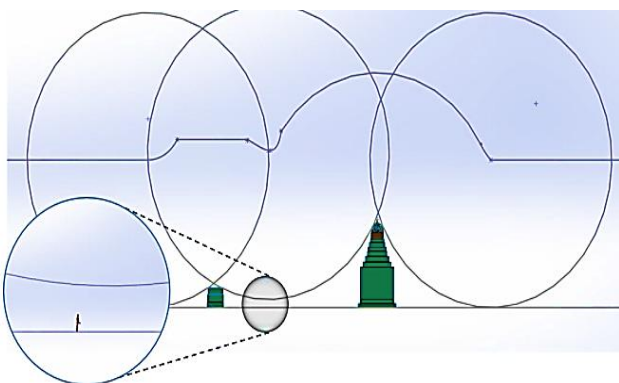
**FIGURE 25.** Loci of LPZ and vulnerable points of human in Gangaikonda Cholapuram

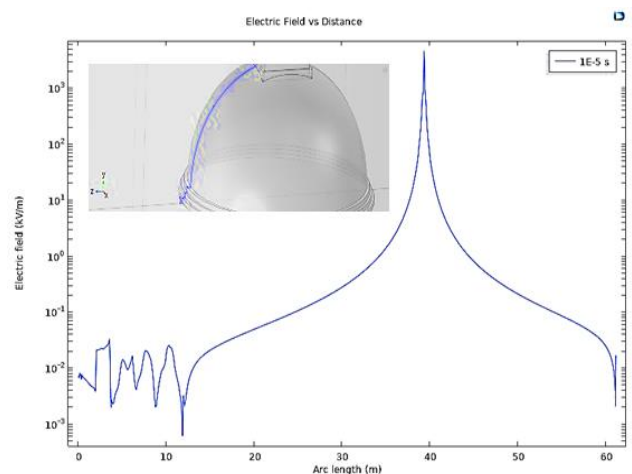
**FIGURE 28.** Electric field distribution during lightning strike on Ruwanweliseya

Fig. 28 and Fig. 29 display the plot of electric field intensity of lightning from the position of the human to that of the point of impact of lightning at the dome of stupa and gopuram.

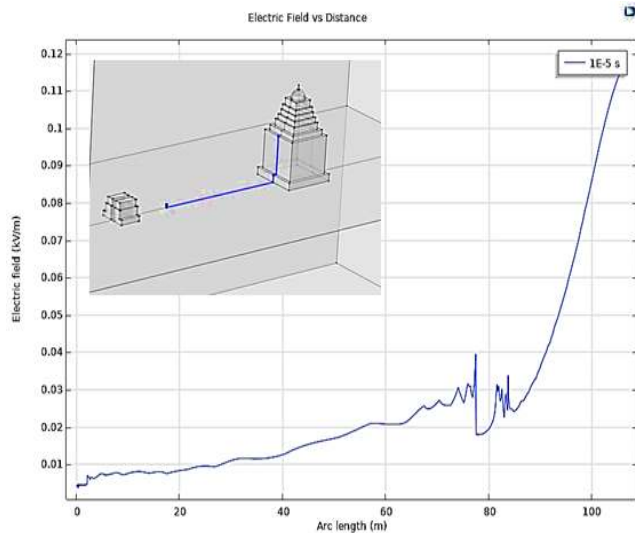
FIGURE 29. Electric field distribution during strike on Gangaikonda Cholapuram

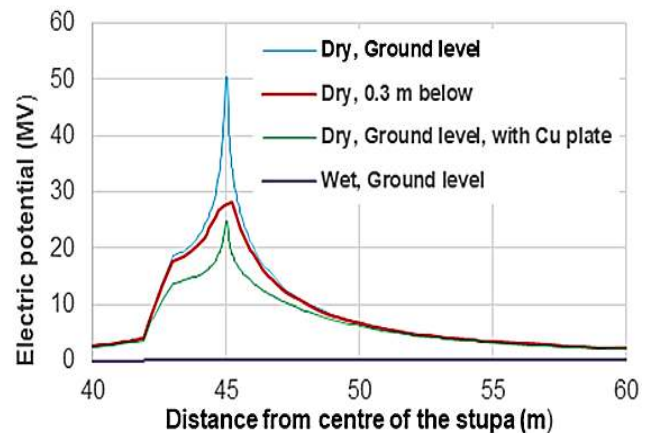
FIGURE 30. Potential distribution along the ground plane in the vicinity of the grounding rod: distance measured from the center of the stupa with earth rod located 45 m away from the center

In order to estimate step voltages, electric potential distribution in the vicinity of the grounding rod during lightning discharge through the LPS has been computed by means of COMSOL simulation. The tested lightning current is 30 kA of a wave shape of 10/350  $\mu$ s. Since the depth of the installed grounding rod from the floor is also important for the step voltage, two cases i.e. rod on the ground surface and rod 0.3 m below the ground surface are also considered. In addition to that dry and wet conditions are simulated by adjusting the conductivity of soil and brick according to Table V. As a special case, a copper plate buried at a 3 m depth and connected to the grounding rod is also considered. Fig. 30 shows potential distribution along the ground level in the vicinity of the rod for few selected cases: (a) dry conditions with rod on ground level, (b) dry conditions with rod 0.3 m below ground level, (c) dry conditions with rod on ground level along with a plate and (d) wet conditions with rod on ground level. As expected, higher ground potential rise occurs near the earth rod for all the cases. Highest potential rise can be observed when the rod is at the ground level under dry conditions, i.e. case (a). Installation of the rod 0.3 m below the ground level reduces the maximum ground potential rise almost by 50%.

However, its effect is limited to the region near the rod. In case of a plate, significant reduction of the potential can be seen over a wide area surrounding the rod. The potential during wet condition is much lesser (<1% of case (a)) than under dry conditions. By considering these observations two worst cases: (a) and (b) have been selected for further analysis. Table VII summarizes the estimated step voltages of the pilgrim (devotee) when standing near the monument for the two cases. Two distances between legs i.e. standard 1 m distance and typical 0.3 m distance are considered.

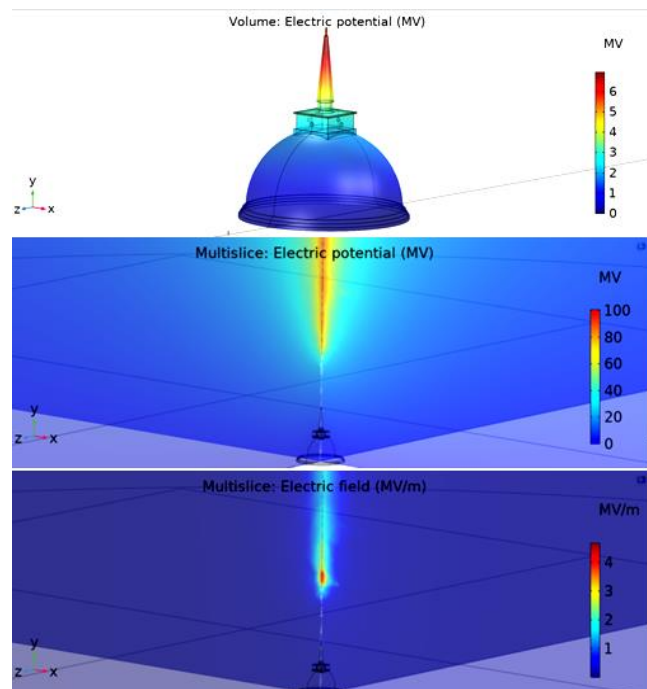
FIGURE 31. Enlarged snapshot view of electric potential and field distribution closer to the stupa for a 30 kA leader at 91.2 m from stupa top

In the case of aborted upward leader, the most onerous condition is during the instance of devotee standing at the furthestmost point from the monument. Table IX and Fig. 31 shows the estimated electric field on the head (cranium) of the human when the downward leader propagates from the cloud towards the human. Accordingly, 93 m is the striking distance for a typical 30 kA current. The estimation of the electric field beyond the striking point i.e. up to 45 m [30] is also included.
